SKANEATELES LAKE AND WATERSHED 2019 ANNUAL REPORT

Volume XLV

Prepared By:
Richard Abbott
Water Quality Management
Department of Water
City of Syracuse, New York

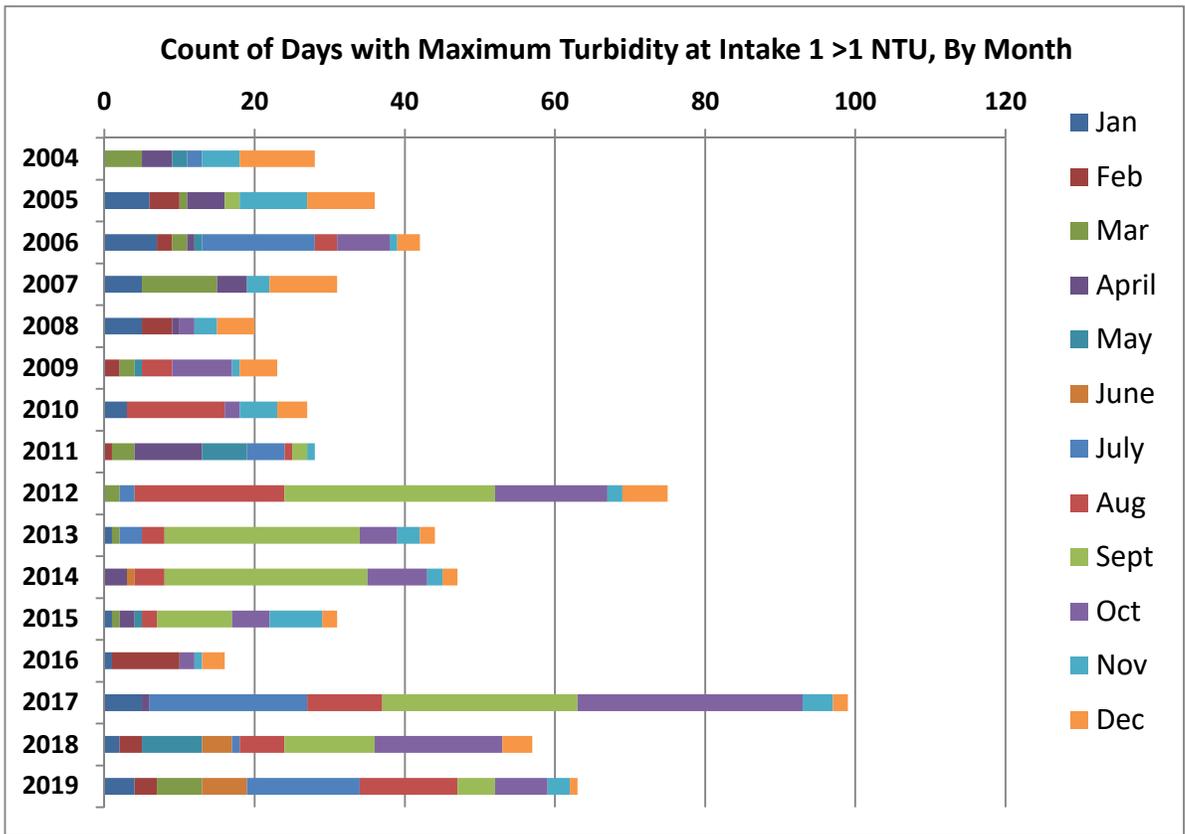
Figure 4 Monthly Counts of Turbidity >1 NTU at Intake 1, 2004-2019

Both Table No. 9 and Figure 4 display the variance in the number of days with maximum turbidity greater than 1 NTU at Intake #1 from 2004 to 2019.

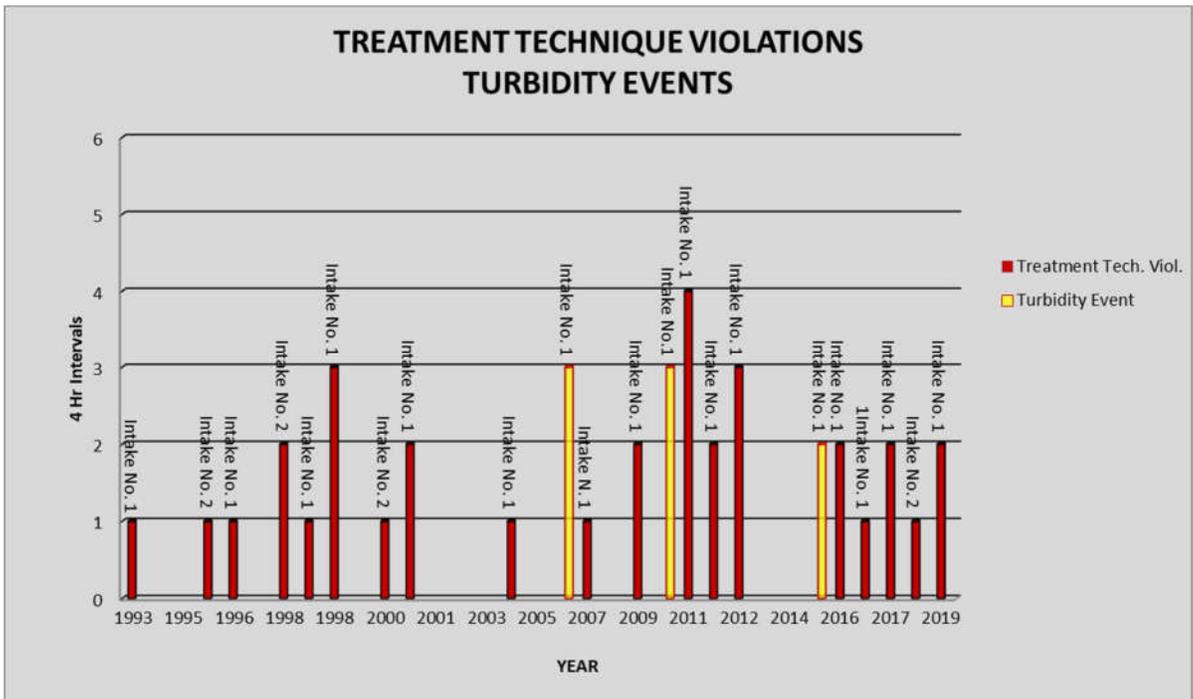
Figure 5 1993-2019 Treatment Technique Violations vs Turbidity Events

Refer to Figure 5 for TTV and Turbidity Events recorded since 1993. The Graph also displays the frequency that 5.0 NTU was exceeded (on a four hour interval) during the TTV or Turbidity Event. Note that in 2015, a Turbidity Event consisted of only two 5.0 NTU exceedances at four hour intervals, comparable to numerous TTV's illustrated in the graph. However, because the intervals were at 8:00 pm and 12:00 am, the conditions set forth by NYSDOH defining a Turbidity Event (a

series of consecutive days during which at least one turbidity measurement each day exceeded 5 NTU) was attained.

One TTV was recorded in 2019. The violation occurred on March 10, 2019 on Intake #1 & #2. A turbidity measurement of 14.21 NTU was recorded at 8:00 am on Intake #2. Turbidity exceeded five NTU on Intake #1 at 8:00 am (6.40 NTU) and 12:00 pm (9.25 NTU). Intake #2 was completely closed by 9:15 am on March 10 and re-opened on March 12. Intake #1 was not shut down.

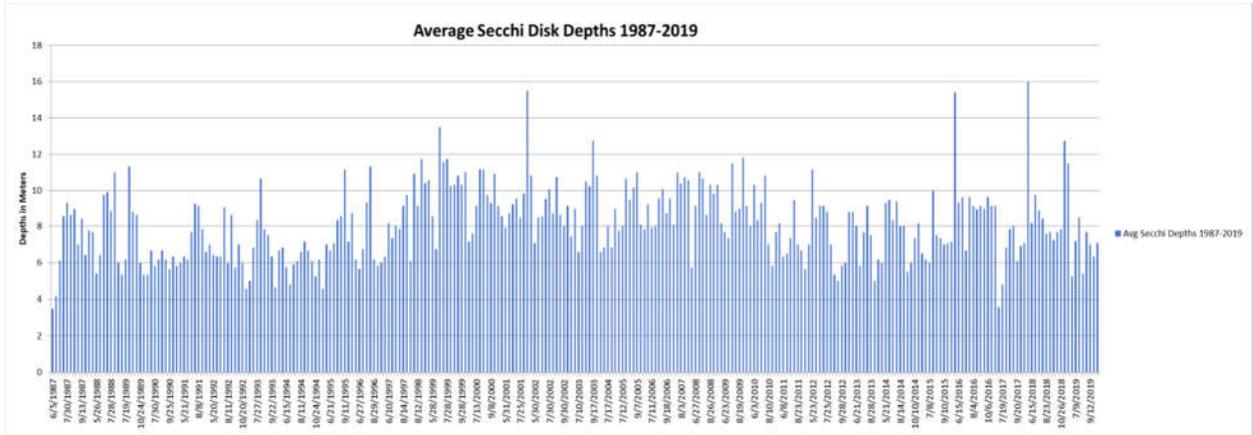
Figure 6 Average Secchi Disk Depths 1987-2019

It is noted that the Secchi disk readings effected during the station sampling can be somewhat skewed. Since stations I and VIII are shallow, the readings are consistently at the bottom, which is usually about six meters (as a result, samples are collected at about 15 feet). It is not unusual for the readings at the other Stations to vary considerably throughout the spring, summer and fall seasons, ranging from four to 16 meters (Figure 6). Figures 7 and 8 illustrate secchi disk depth variations between early summer and fall. References to Secchi disk readings in the narrative below are adjusted, i.e., only Stations II – VII were used to determine averages.

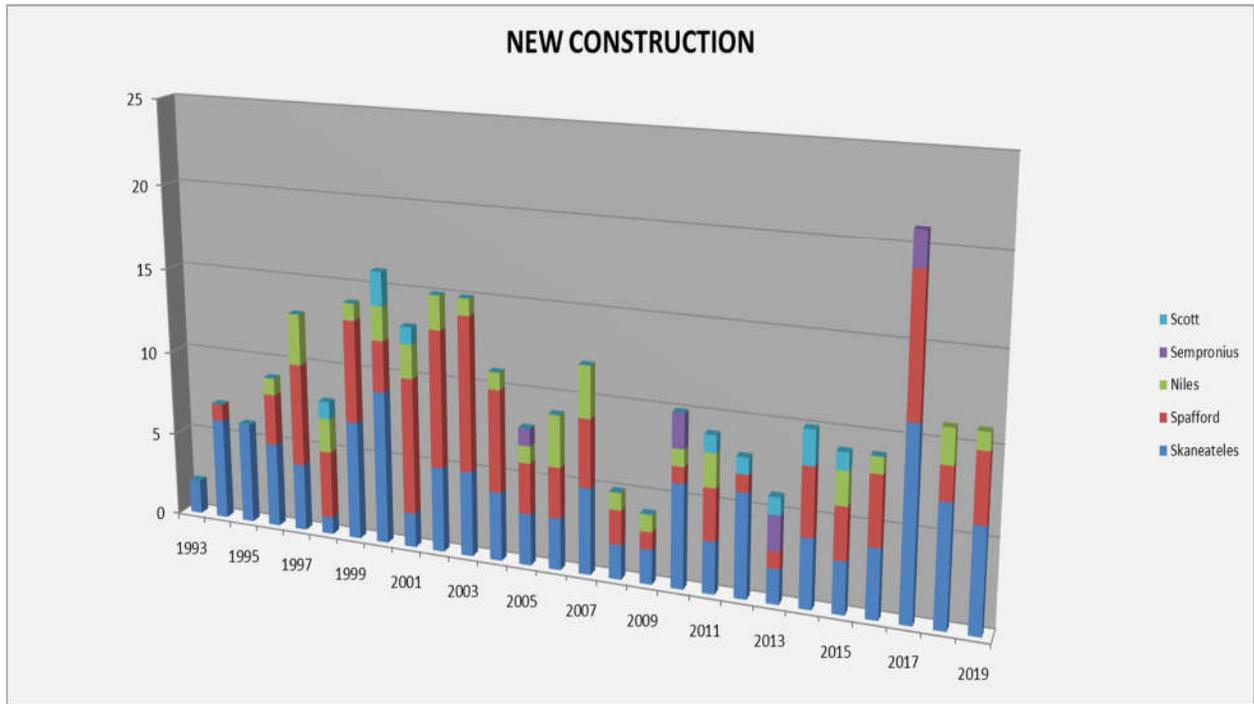
Figure 10 New Construction Activity within the Skaneateles Lake Watershed 1993-2019

The Watershed Protection Program reviewed a total 56 Building and Zoning Permit Applications in 2019. As discussed above, 11 were new housing starts. Twenty applications were additions or renovations to existing dwellings and the remaining 25 applications included shoreline structures, accessory structures, landscape features or proposed subdivisions and lot line relocations. Figures 10 through 14 illustrate new construction and renovation proposals reviewed by the City of Syracuse and monitored throughout project duration in the Skaneateles Lake Watershed since 1993.

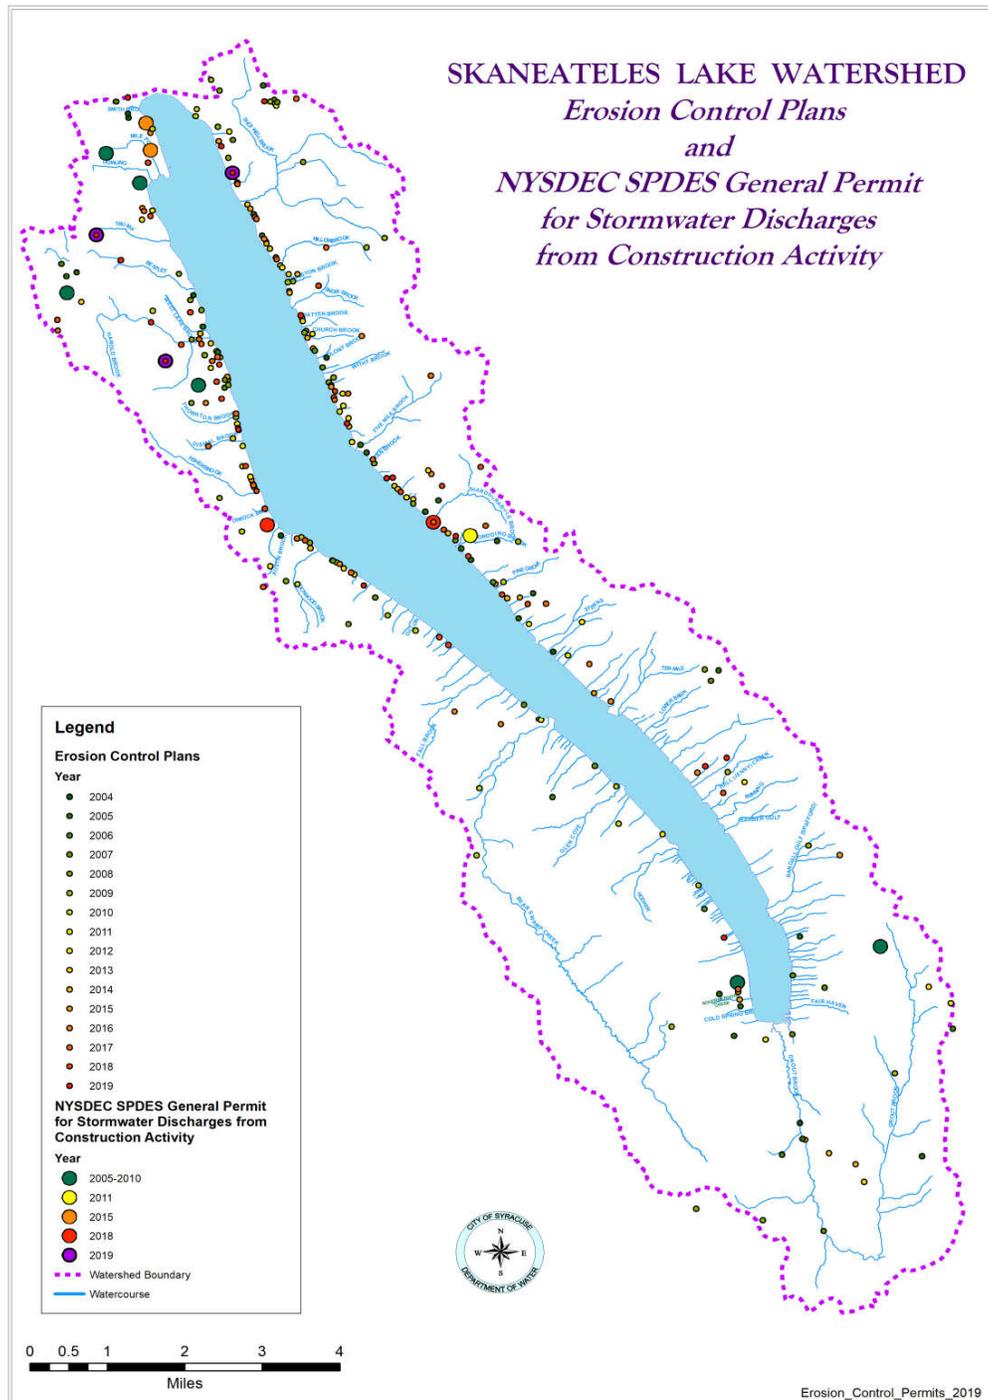
Figure 14 Erosion Control Plans/NYSDEC SPDES Permits

As of 2004, the Skaneateles Watershed Rules and Regulations require property owners proposing to disturb 5,000 square feet or greater of land in defined environmentally sensitive areas to submit a Sediment and Erosion Control Plan (SECP) to the City of Syracuse for review. In 2019, 23 SECPs were reviewed. A NYSDEC SPDES General Permit for Storm water Discharges (GP-0-15-002) is required in New York State for all construction activity over one acre. Three permits were issued for construction activity in the Watershed in 2019 under GP-0-15-002. Figure 14 illustrates SECP's reviewed and SPDES General Permits issued within the Skaneateles Lake Watershed since 2004.

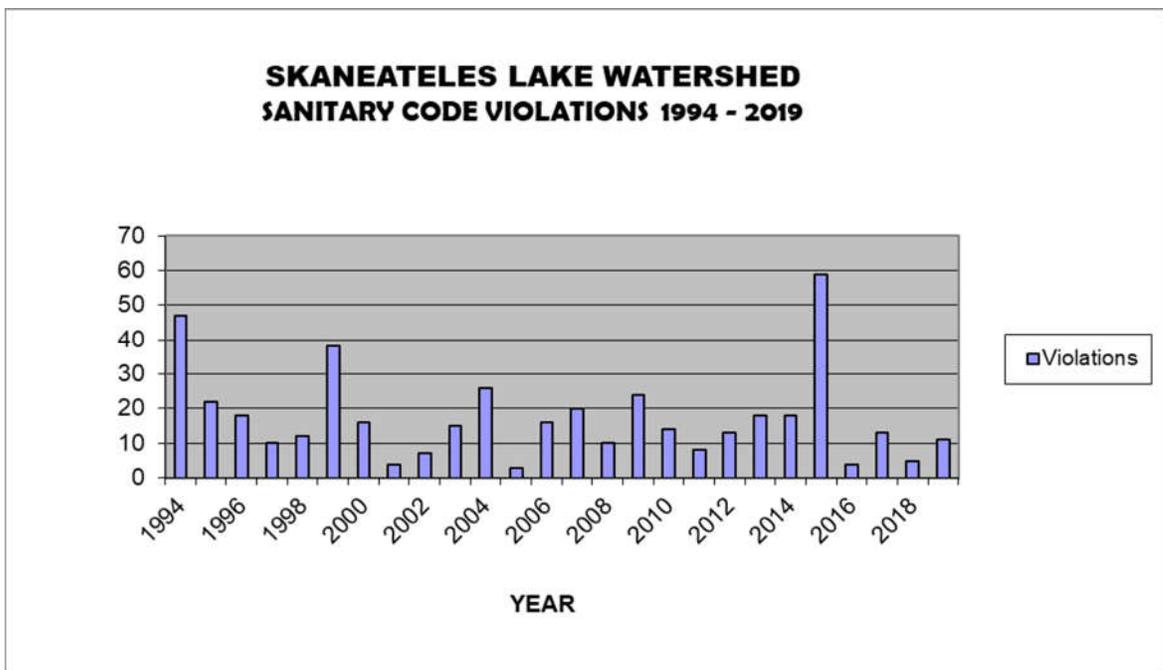
Figure 15 Skaneateles Lake Watershed Sanitary Code Violations 1994-2019

The enforcement of Sanitary Code violations is the responsibility of the respective County health departments. Alleged violators are issued a Violation Notice from the City of Syracuse and given five working days to reply and declare their intent to affect the necessary repairs. If there is no response, or if the property owner refuses to abate the problem, the violation is forwarded to the respective county health department for enforcement. Sanitary Code violations identified by Watershed Inspectors since 1993 are shown in Figure 15.

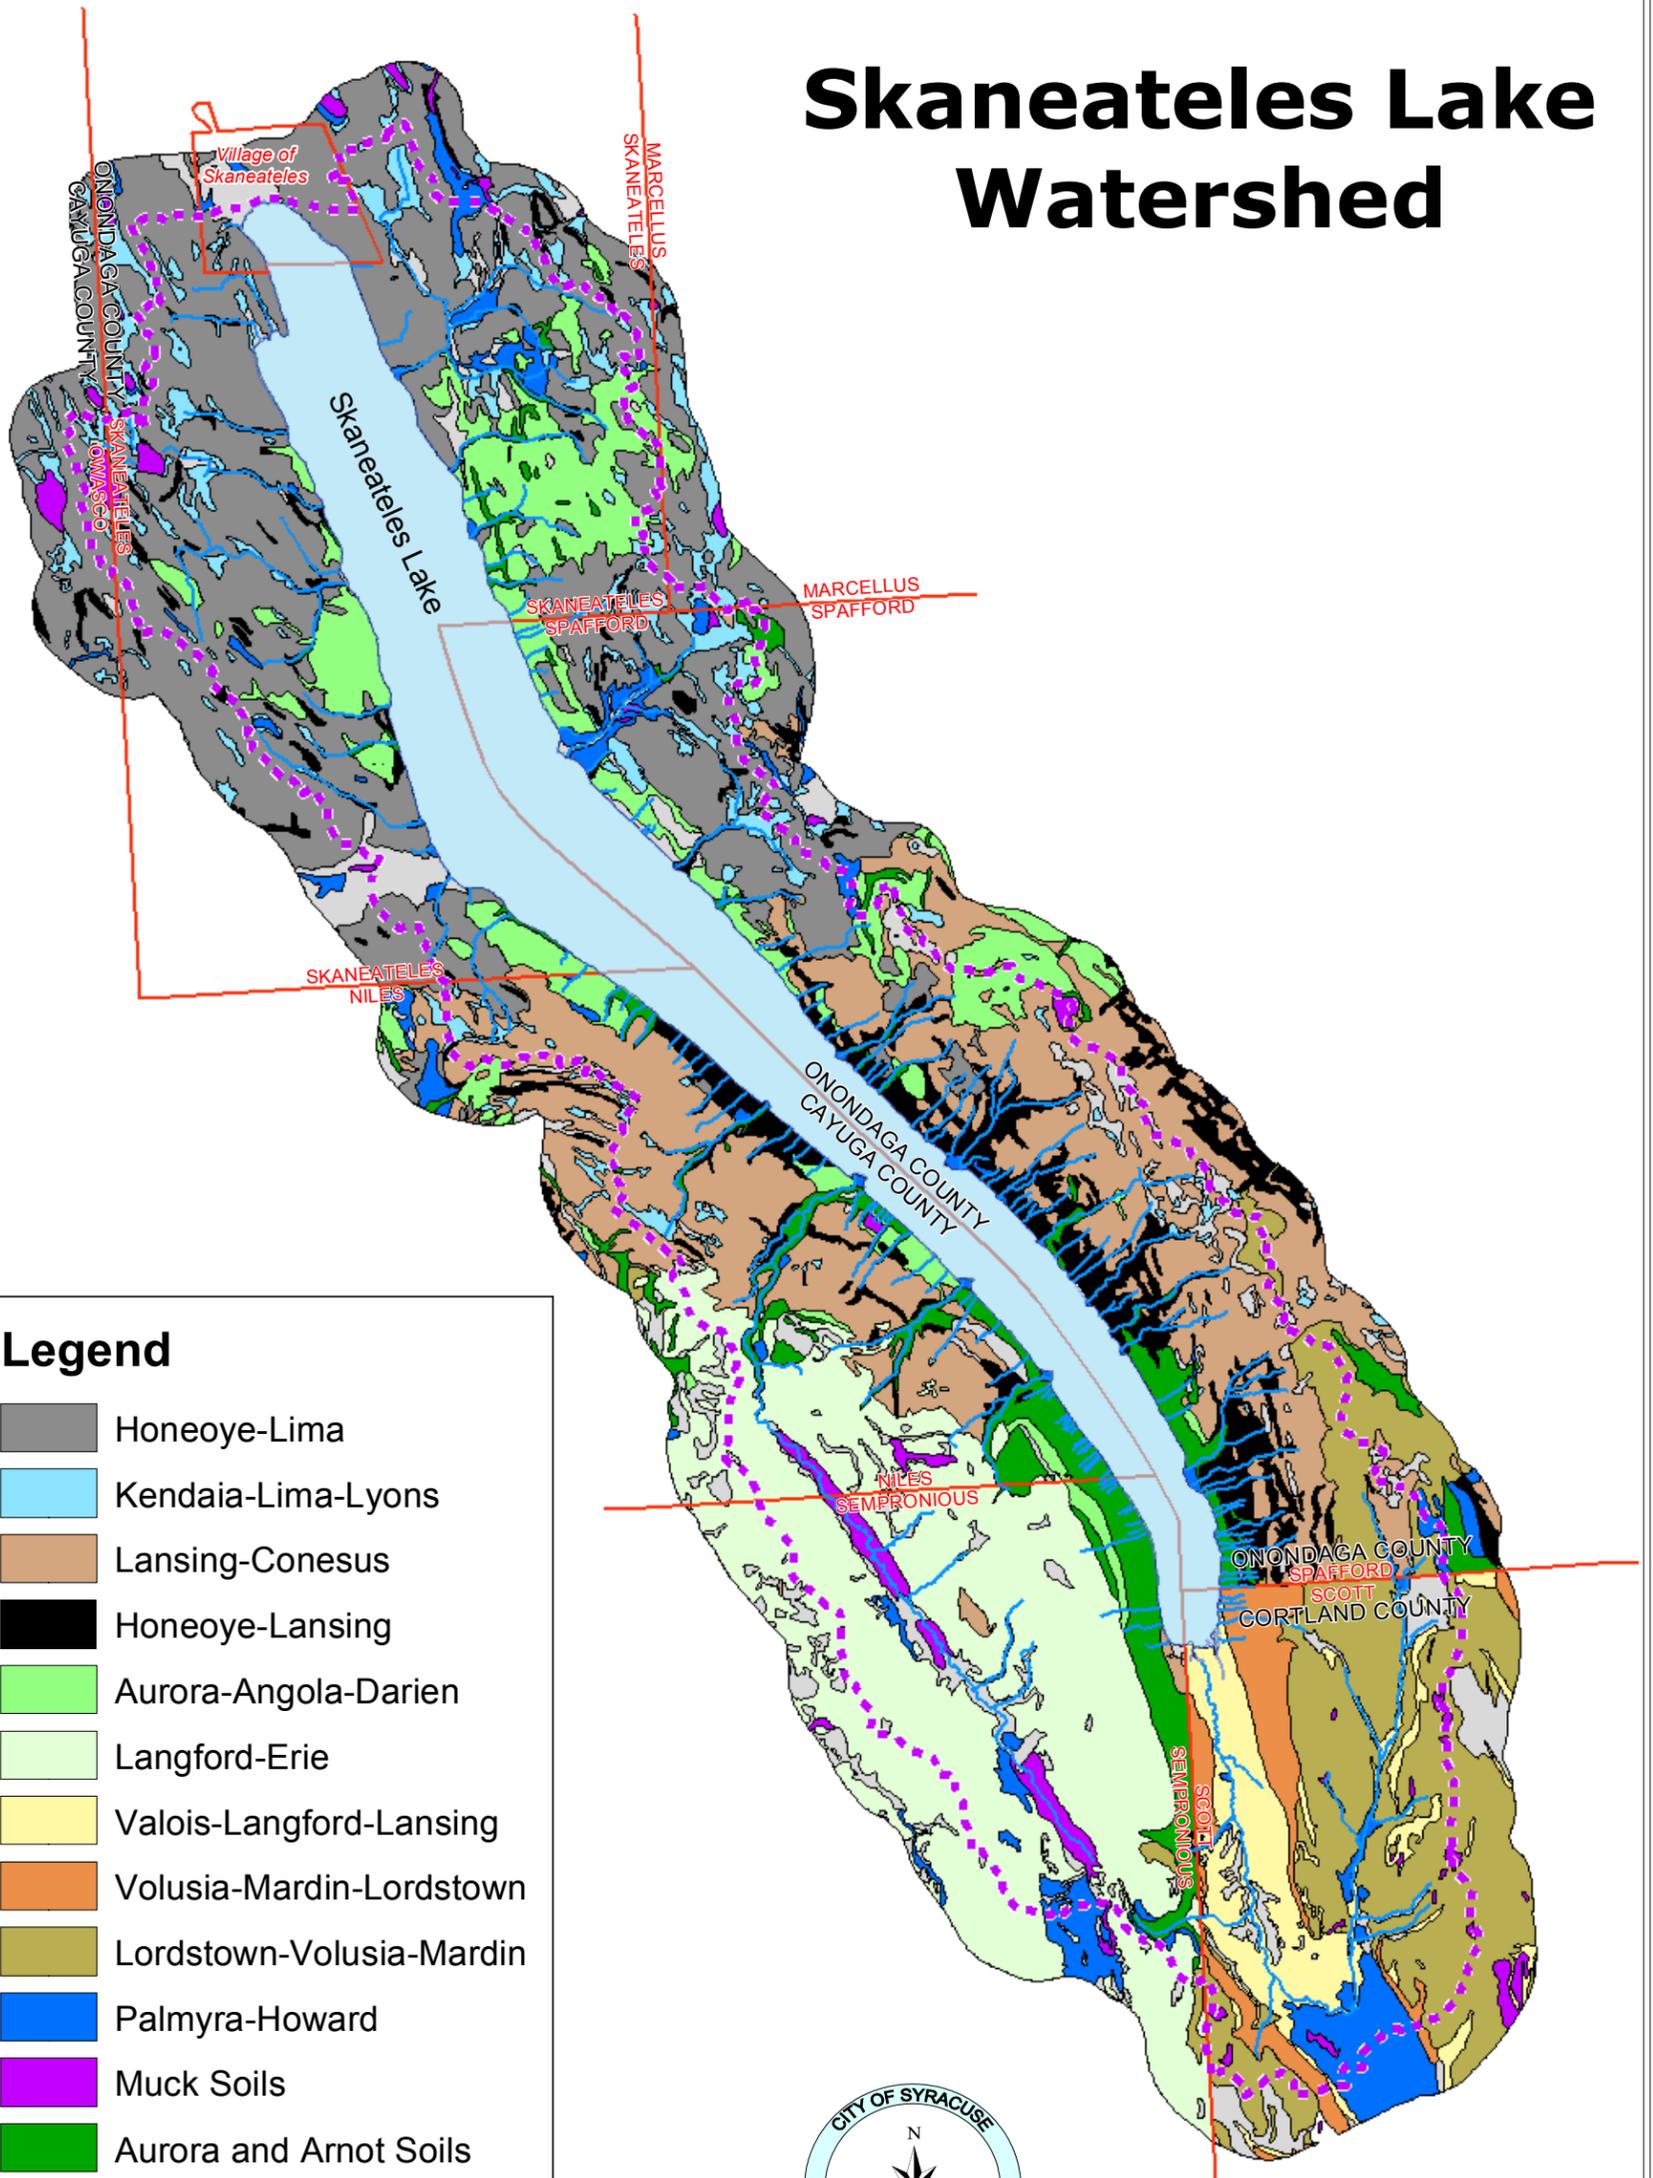
Exhibit B: Soil Associations Map

- Honeoye-Lima
- Kendaia-Lima-Lyons
- Lansing-Conesus
- Honeoye-Lansing
- Aurora-Angola-Darien
- Langford-Erie
- Valois-Langford-Lansing
- Volusia-Mardin-Lordstown
- Lordstown-Volusia-Mardin
- Palmyra-Howard
- Muck Soils
- Aurora and Arnot Soils
- Minor Soil Associations
- Streams in the Watershed
- Watershed Boundary
- Municipal Boundaries

There are several soil associations within the watershed (Exhibit B and Table No. 2). The associations discussed below account for 80% of the watershed area and are considered representative of the character of the watershed. The remainder (20%) will not be discussed. It is noted that the associations generated by the GIS compare well, though not exactly, with the U.S. Department of Agriculture Soil Surveys prepared for each county. It would appear that this is due to the inherent discrepancies often found between maps and mapping systems.

The major soil associations found in the northern two-thirds of the watershed are: Honeoye-Lima, Lansing-Conesus, Honeoye-Lansing, and Aurora-Angola-Darien. These associations are generally characterized as deep, medium textured silt loams and gravelly silt loams. Slopes range from 2-8%, except the Honeoye-Lansing Association that has slopes of 15-25%. They are moderately well, to well drained. Permeability is slow to moderate, and seasonal ground water is generally 15" to <36".

The Langford-Erie Association comprises the southwestern portion of the watershed (about 15% of the watershed). It is considered a deep, medium textured silt loam with slopes from 2% to 25%. The soils are poorly to well drained, and slowly to moderately permeable. A medium textured fragipan can be observed in some areas. Seasonal ground water and bedrock are shallow at 6" to 20", and 20" to 40", for the Langford and Erie series, respectively.

There are three (3) associations found primarily within Cortland County (southeastern portion of the watershed): Valois-Langford-Lansing, Volusia-Mardin-Lordstown, and Lordstown-Volusia-Mardin. This is equivalent to about 13% of the watershed. The soils are medium textured silt loams and gravelly silt loams. Slopes can be extreme and can exceed 55%. They are poorly to well drained and very slowly to moderately permeable. Seasonal ground water ranges from 18" to 60".
